**St. Lawrence River/Thousand Islands  
Emerald Ash Borer Early Detection Survey  
SLELO-PRISM Early Detection Surveillance**

June 3<sup>rd</sup> and 29<sup>th</sup> 2015

Report prepared by Elizabeth MacEwen and Caitlin Muller on July 1, 2015.

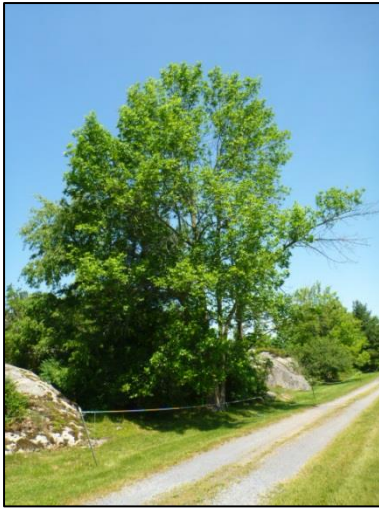
**Figure 2:** Some canopy die-back seen in an ash tree stand at Keewaydin State Park at waypoint 004 on June 3<sup>rd</sup>.

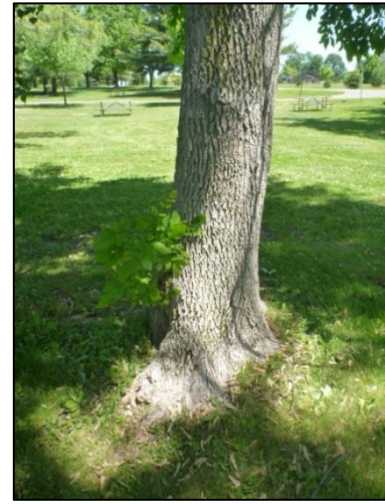
**Figure 3:** Very little epicormic growth seen at Keewaydin State Park at waypoint 005 on June 3<sup>rd</sup>.

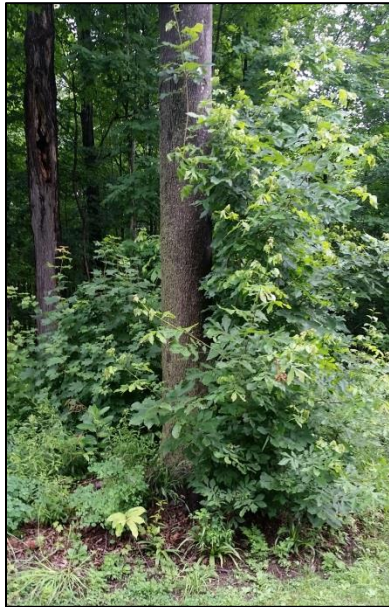
On June 29<sup>th</sup> Early Detection Field Crew member Caitlin Muller re-visited the three parks. The ash stands marked by Elizabeth MacEwen in the prior survey were re-visited, and any ash trees that showed any symptoms of stress were marked. Jacques Cartier State Park had a small stand of ash present on both sides of the main road. Some of these trees displayed epicormic growth and canopy dieback. One ash had larger epicormic sprouts, indicating that the tree had been stressed for a long period of time (Figure 6).

**Figure 6.** Larger epicormic sprouts found at Jacques Cartier State Park. Photo taken by Caitlin

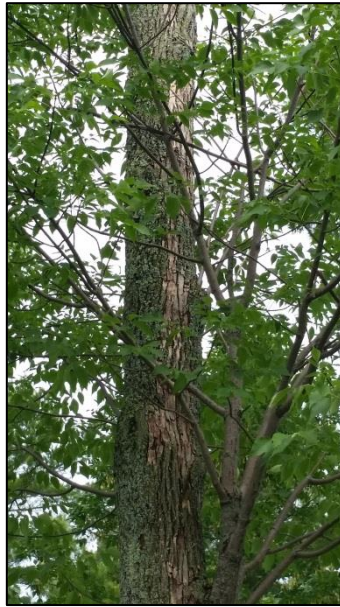
At Kring Point State Park there was a large amount of stressed ash trees. Most ash trees in this park displayed blonding, the removal of the trees bark by woodpeckers, on the entire tree (Figure 7). The blonding was not drastic in most cases but was worth noting. The trees displaying blonding had varying amount of canopy dieback (Figure 8). On a few trees large circular exit holes were observed which may be due to native borers. Keewaydin State Park had few ash trees present in the campground. Those observed showed slight dieback and occasional epicormic sprouts.

**Figure 7.** Blonding observed at Kring Point State Park. Photo taken by Caitlin Muller.

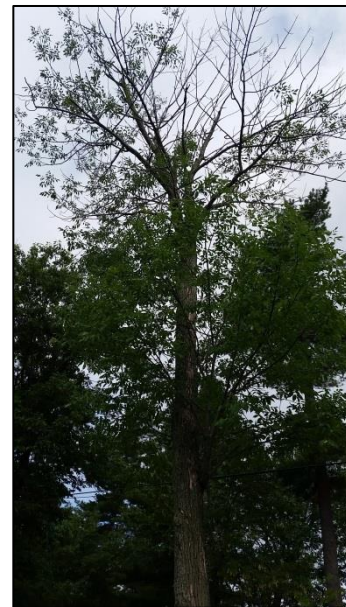
**Figure 8.** Canopy dieback observed in Kring Point State Park. Photo taken by Caitlin
