Delta Lake

SLELO-PRISM Aquatic Invasive Species Early Detection Surveillance

June 27, 2013

Report prepared by Logan West, Mike McHale and Rob Williams on 7/2/13

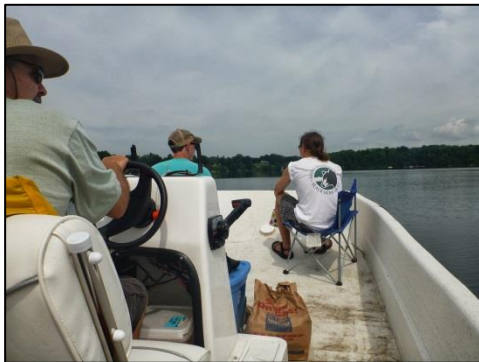
Figure 5: Carolina Skiff powerboat used on Lake Delta

A flat-bottomed motorboat (Figure 5) was used to transport the crew to each HPA location. Samples were collected by throwing a weighted rake (rake toss method, Figure 6) attached to a rope into the water from both sides of the boat to gather submerged aquatic vegetation samples and to measure water depth (Table 2). This technique allowed the crew to determine what species were present in that location. Once the samples were collected, the species were identified, recorded, and determined to be either invasive or noninvasive (Table 2). Visual observations of vegetation in the area were also recorded.

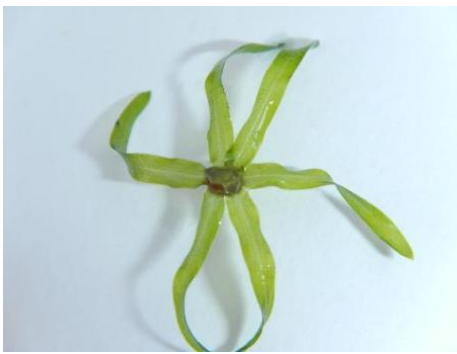
Upon observation of the floating plant fragments, elodea species were observed along with other plant fragments having similar leaf arrangements in whorls of 5 and 6 leaves (Figure 7 and 8). Samples were then taken to the SLELO field office and observed under magnifying apparatus which showed serrated leaf margins on some of the plants (Figure 9), which suggested *Hydrilla (Hydrilla verticillata)*.

Figure 7: Close-up of 6-leaf whorl

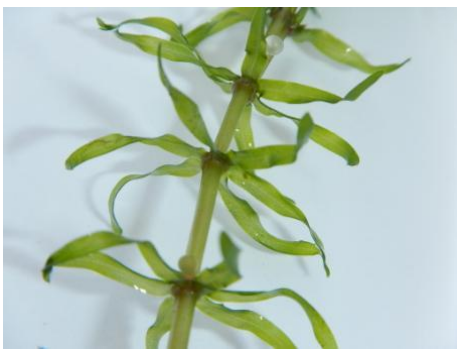
Figure 8: Close-up of 5,6 leaf whorl.

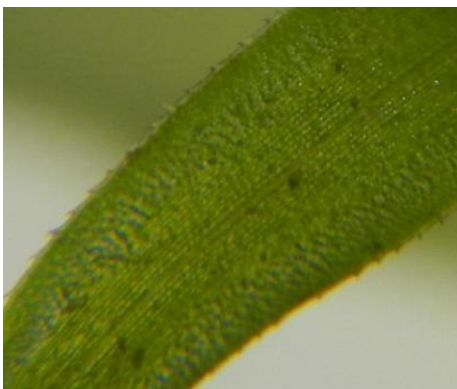
Figure 9: Magnified view of serrated leaf margin.

Although the number of whorls present is deceiving, both scientists determined that this species was likely to be (*Elodea nutallii*).

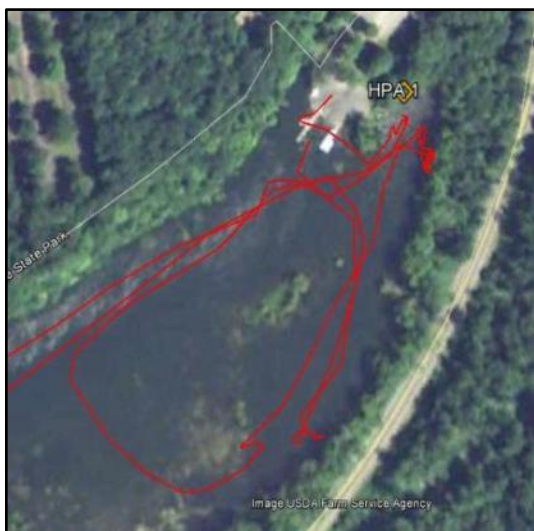
Figure 10: HPA-1

HPA 1: Observed a floating mat of vegetation that had no obvious rooted parts. The vegetation most likely was brought in by the current to this area. This was in close proximity to the boat launch and could have been introduced by transient boats foreign to Lake Delta.

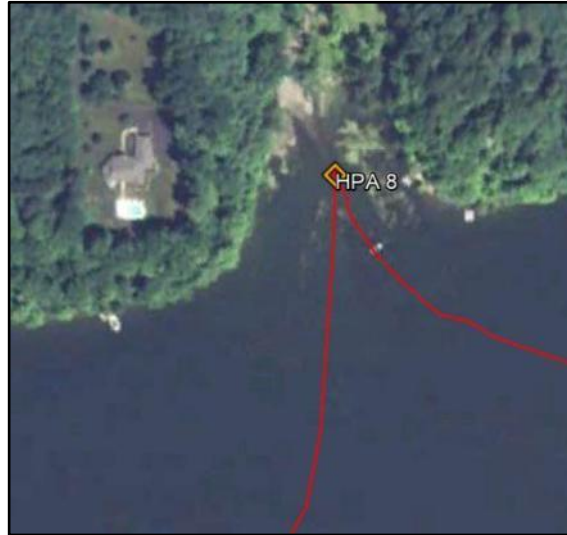
Figure 15: HPA-8

Location: Delta Lake							Date: 6/27/2013
Point	Latitude Longitude	Throw	Depth (ft)	# Spp.	# Inv.	Spp. Present	Notes
HPA-1	43.28632	1	3	5	0	FW, BLPW, WSPW, CLPW, EL	Samples taken, possible hydrilla
	-75.4166	2	4	5	0		
HPA-3	43.27462	1	12	0	0		Steep banks, deep water
	-75.4377	2	13	0	0		
HPA-4	43.29235	1	5	3	0	BLPW, EL, WSPW	
	-75.466	2	5	3	0		
HPA-5	43.29786	1	5	1	0	BLPW	Pithophora algae seen
	-75.4561	2	6.5	1	0		
HPA-6	43.30954	1	6	2	0	BLPW, WSPW	
	-75.3968	2	6	2	0		
HPA-7	43.28217	1	9	3	0	CT, FW, BLPW	
	-75.4501	2	10	1	0		
HPA-8	43.29972	1	X	1	0	BLPW	Phragmites observed near shore
	-75.4449	2	X	1	0
