St. Lawrence Eastern Lake Ontario Partnership for Regional Invasive Species Management

2014 Field Report

Addendum to Black Lake

Water Chestnut & Hydrilla Surveillance

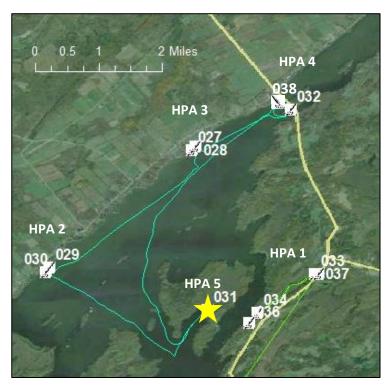
Figure 2. Map of Black Lake with new HPA, shown with star at WP 031

Field crew members returned to the HPA's determined in 2012. One new HPA (HPA 5-WP 031) was suggested in a quiet cove on Upper Big Bay (**Figure 2**). Prevailing westerly winds could push plant species from cottages on the southern side of the lake into this quiet cove, where invasive plants could thrive.

HPA 5: ***NEW*** WP 031, Quiet cove on Upper Big Bay

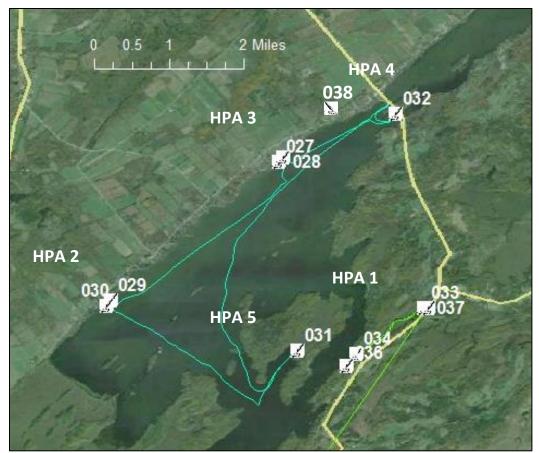
Map 1. Survey route around Black Lake, with rake toss locations. Blue line is motor boat survey route; green line is canoe survey route

A flat bottomed motor boat was used to bring field crew members to HPA's 2, 3, 4 and 5. In 2012 HPA 4 was visually surveyed by walking the bridges. In 2014 HPA 4 was surveyed from the water in the motor boat. A canoe was used to survey HPA 1. The rake toss method was used along with visual surveillance. Every invasive species occurrence was noted. After data collection, invasive species' occurrences were recorded on the iMap database.

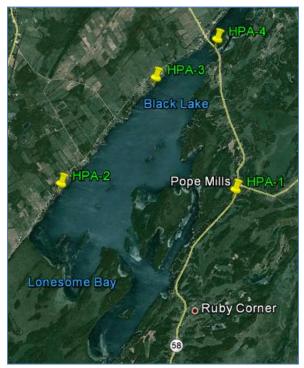
Figure 4: Map showing locations of the four HPAs chosen for Black Lake.

HPA-1: Begins at unimproved boat launch on Route 58 south of the hamlet of Pope Mills, giving access to Fish Creek leading into Black Lake. Survey area includes the length of Fish Creek leading to Black Lake and two quiet coves adjacent to Fish Creek's outlet on Black Lake.

HPA-2: McClear's Cottage Colony & Campground, 2477 County Route 6 on the northwest shore of the lake. Survey area includes the areas immediately surrounding the docks and informal boat launch. Access is by permission of the property owners.

HPA-3: New York State OPRHP Black Lake Boat Launch, located along County Route 6, north of McClear's. Survey area includes the areas immediately surrounding the improved concrete boat launch.

HPA-4: Bridges on Route 58, crossing narrow portion of Black Lake near the hamlet of Edwardsville. Visual survey conducted from both sides of the bridge; informal access to the water may allow for launching of canoe if necessary.
