South Sandy Creek: Aquatic Restoration Initiative Phase III

Aquatic and Riparian
Invasive Species
Monitoring, Management,
and Habitat Restoration

2022 Final Report

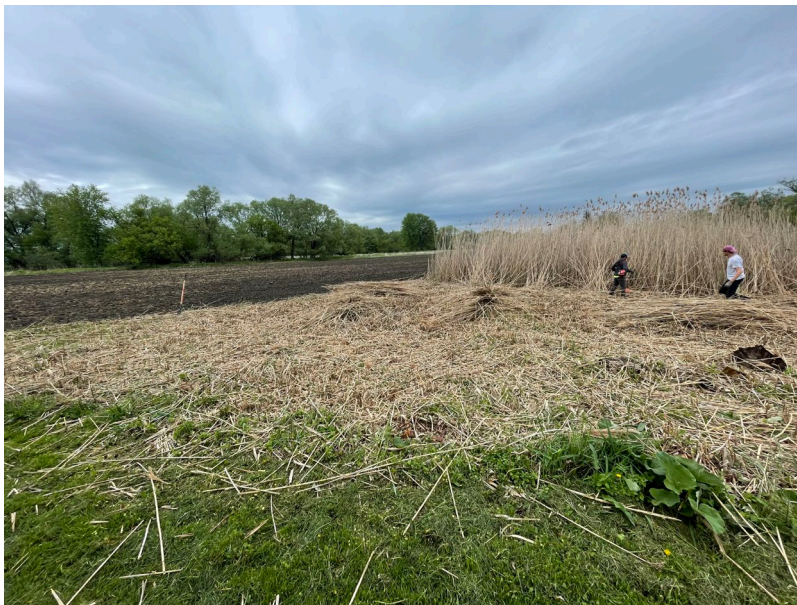
Once that area was cleared, the crew moved to the *Phragmites* patch located downstream and south of the bird observation tower. Again, the dead stems were cut as close to the ground as possible. However, it was determined that the process of removing debris and transporting it to the parking lot area for disposal would cause potential spread of seed throughout the entire site, as well as cause significant damage to the trail due to the wet site conditions at that time and the multiple trips needed to move that material. In consultation with SLELO PRISM's representative, it was decided that the debris would be collected and piled in two locations on the edge of the *Phragmites* patch away from the creek and in discrete areas. The piles were then covered with large, neutral colored tarps that were secured with stakes and logs to contain the debris and potentially damage any seed with the high temperatures that would be experienced under the tarp during the summer. The tarps would be removed at the end of the season.

Crew members removing dead *Phragmites* stems

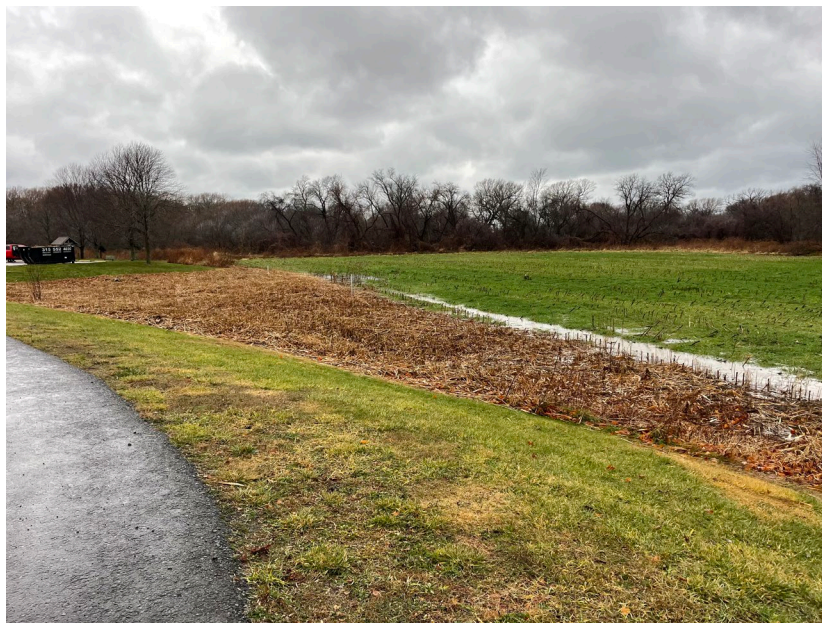
To wrap up on-site activities for this season, Cardno returned to the site on November 30th to cut and remove the dead *Phragmites* stems in the plot located northeast of the boat launch parking lot. Crewmembers again cut the stems near the ground with the use of brush saws. It was observed there was considerably less material and growth within the plot as compared with what was seen in the spring. Once the stems were cut, they were collected by hand and disposed of in a roll-off dumpster that was again rented for this work. Approximately 12 cubic yards of material was collected.

Phragmites treatment plot after dead stem removal

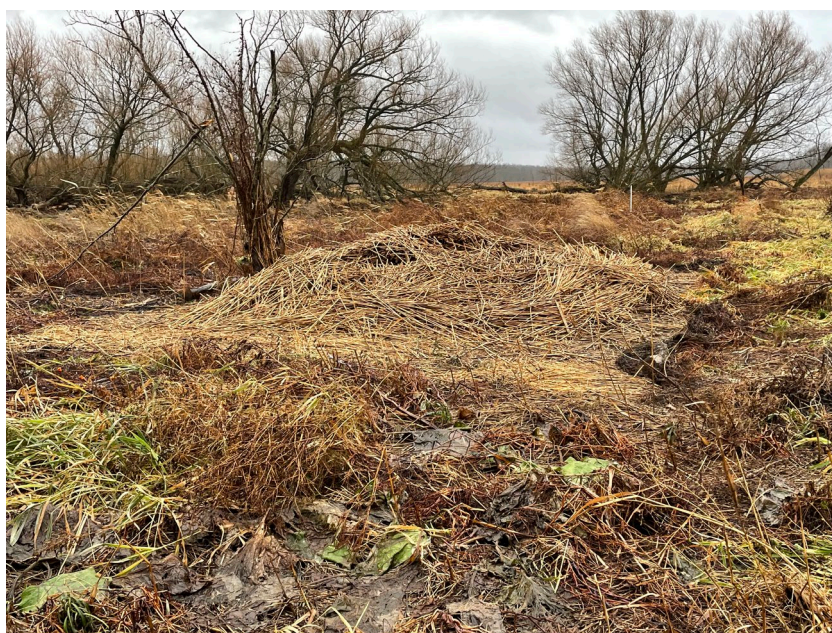
During this visit, the crew also removed the tarps that were covering the *Phragmites* debris piles located in the far downstream treatment plot. The tarps and any loose fragments were collected, bagged, and taken off-site for disposal.

Phragmites pile with the tarp removed

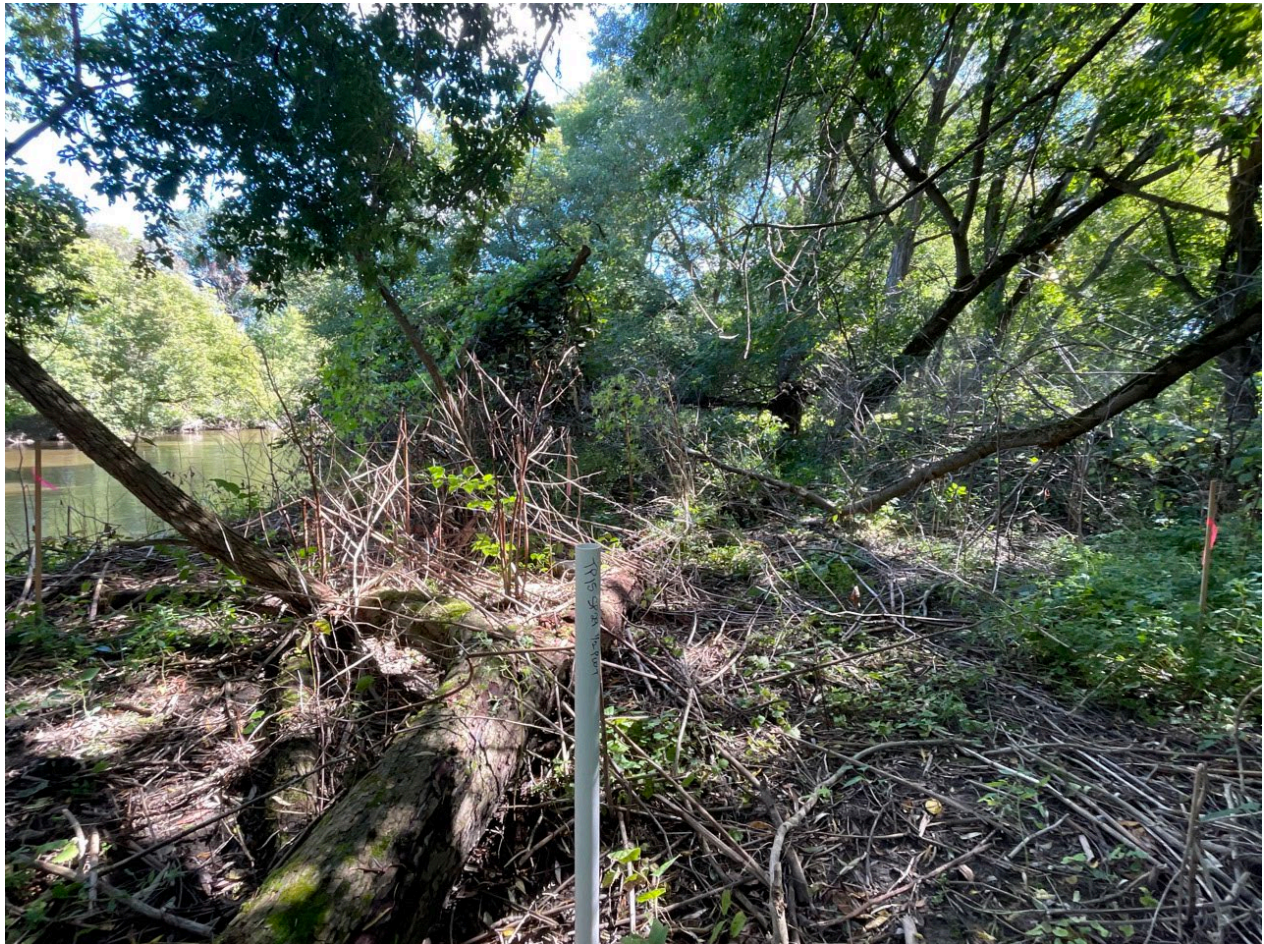
Photograph taken of SP #29 in TP #15

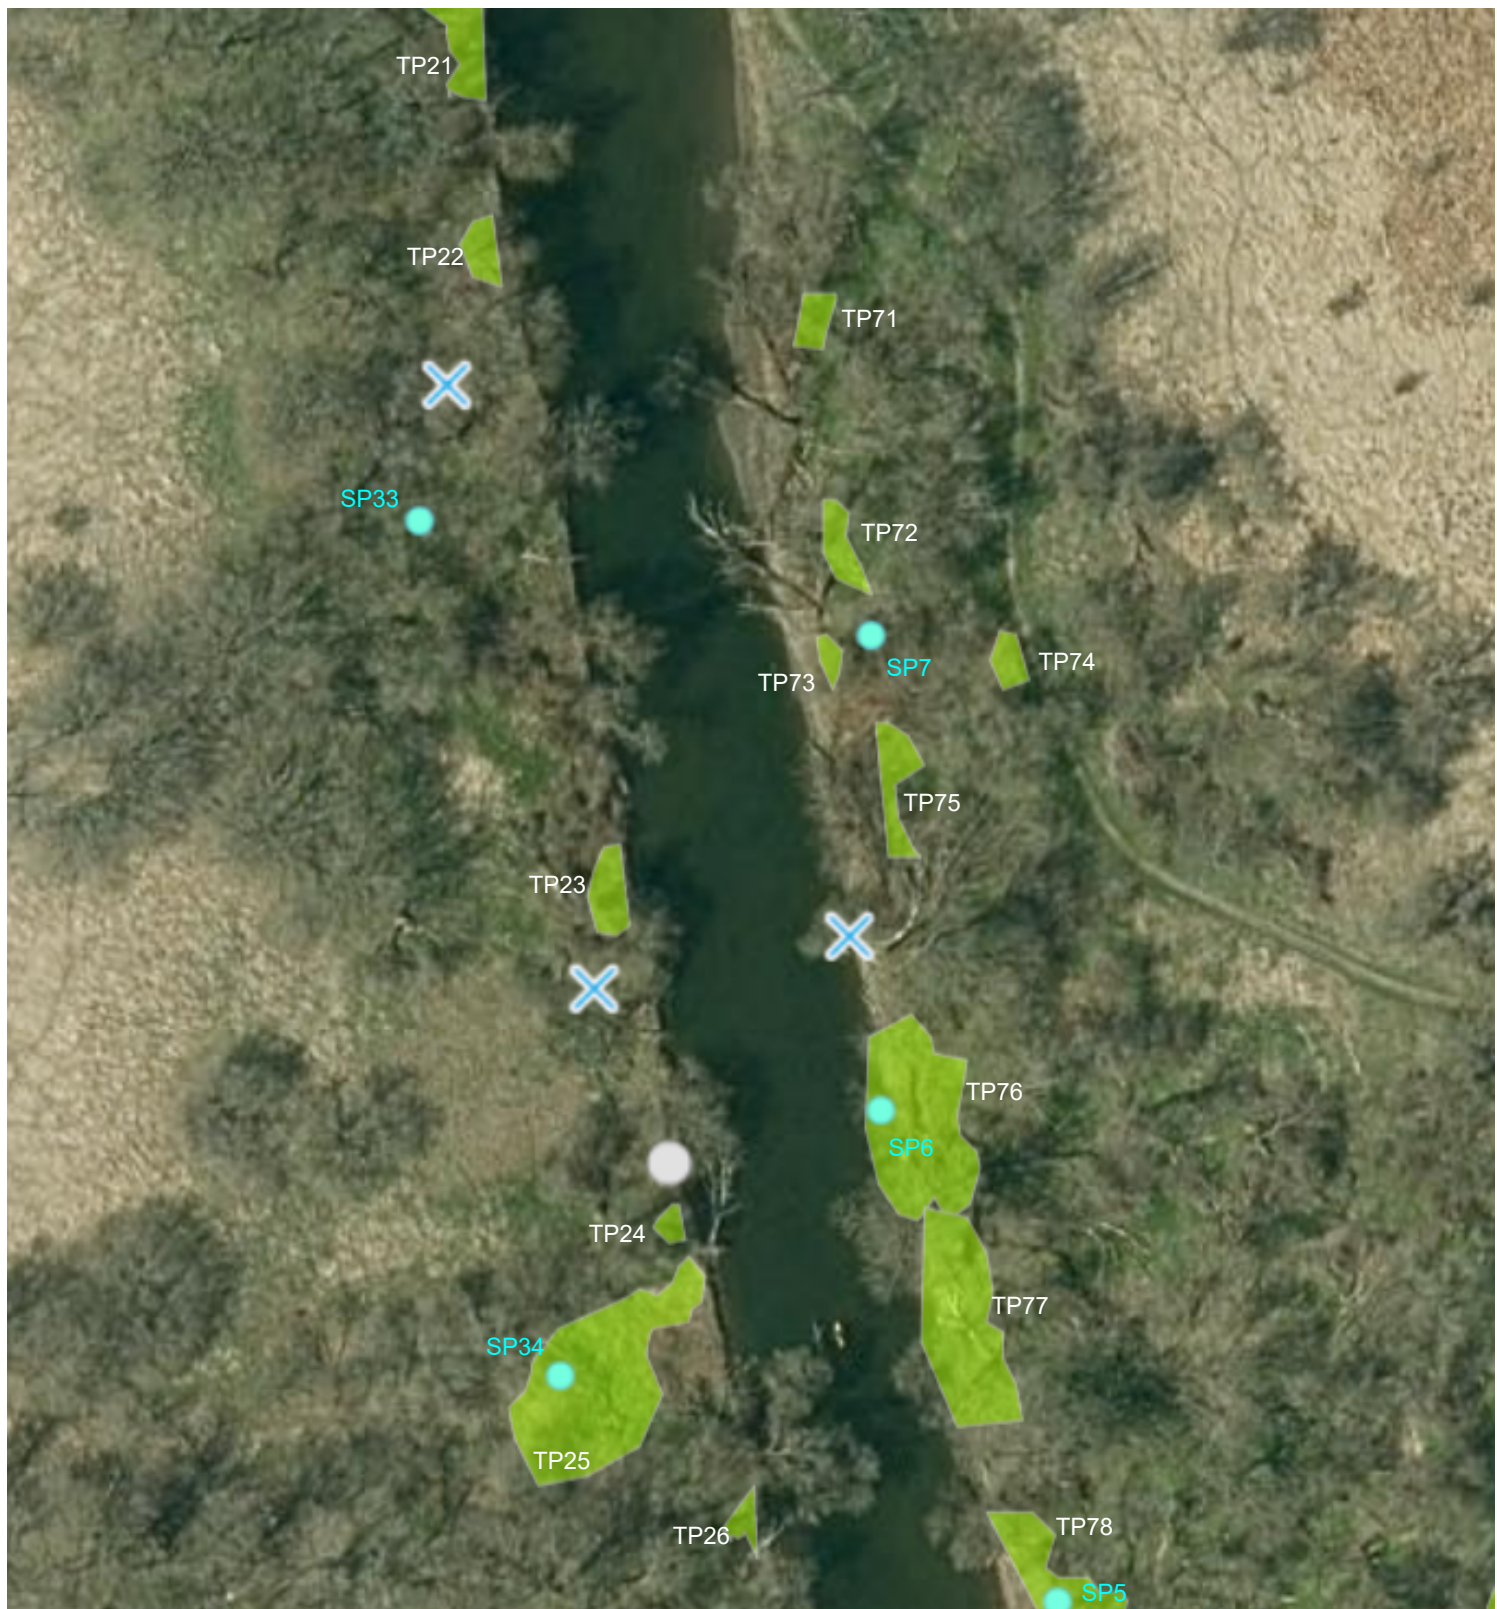
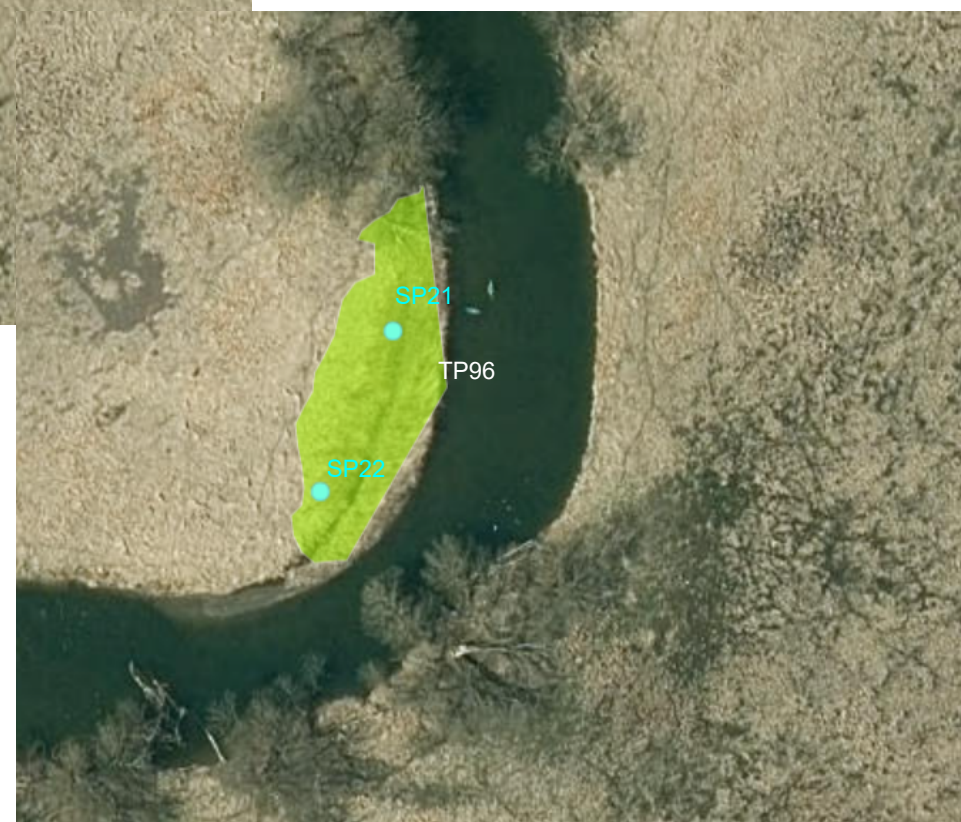
TREATMENT AND SAMPLE
PLOT MAPS

A map of the South Sandy Creek treatment areas can be found in Appendix C. The plots have been numbered and a chart with quantities of herbicide applied per plot can be found in Appendix D.

Prior to the first invasive species monitoring visit, Cardno chose 40 random points across the site to place the invasive species monitoring plots. 4 of these plots were located outside mapped treatment plots to survey growth and species composition outside of areas that had been treated for invasive species. Another 4 were placed inside the two *Phragmites* treatment plots. The remainder were to be located within plots that have been treated for Japanese knotweed. Additionally, they had to be placed in a treatment plot and position that would allow a 9 m² sampling area to be established. Unfortunately, only 24 plots were identified that could hold such a sampling area due to the relative size and shape of the treatment polygons. Consequently, another 8 treatment plots were identified that could contain a “half plot” measuring 4.5 m² in area. This allowed Cardno to survey the total area that was proposed in the original work plan. Potential sampling locations were submitted to SLELO PRISM’s representative prior to the first monitoring visit. These mapped points can be found in Appendix C.

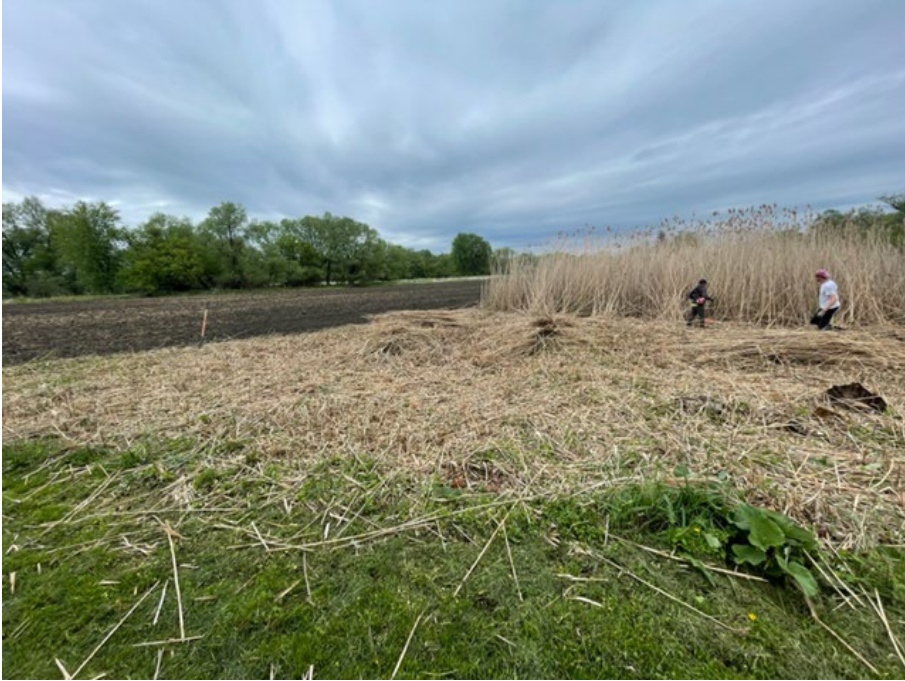
Common reed stem removal near the parking lot

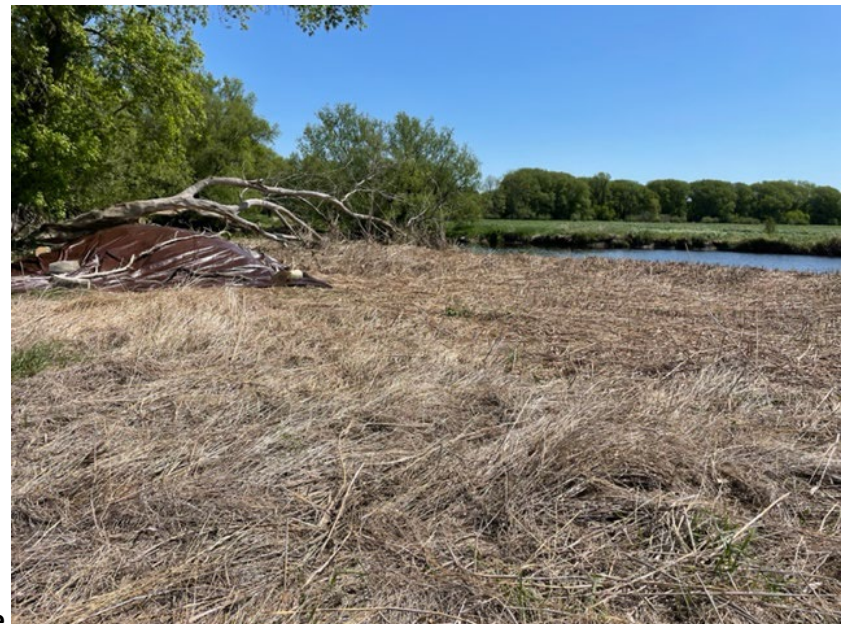
Cleared downstream common reed patch and covered debris pile

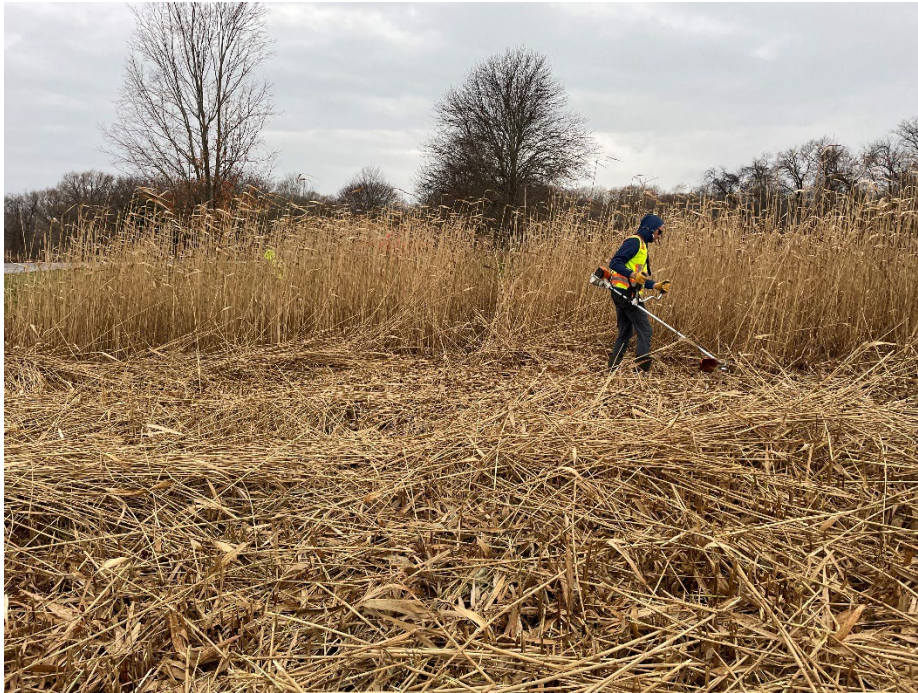
Cardno crewmember a using brush cutter to mow Phragmites stems

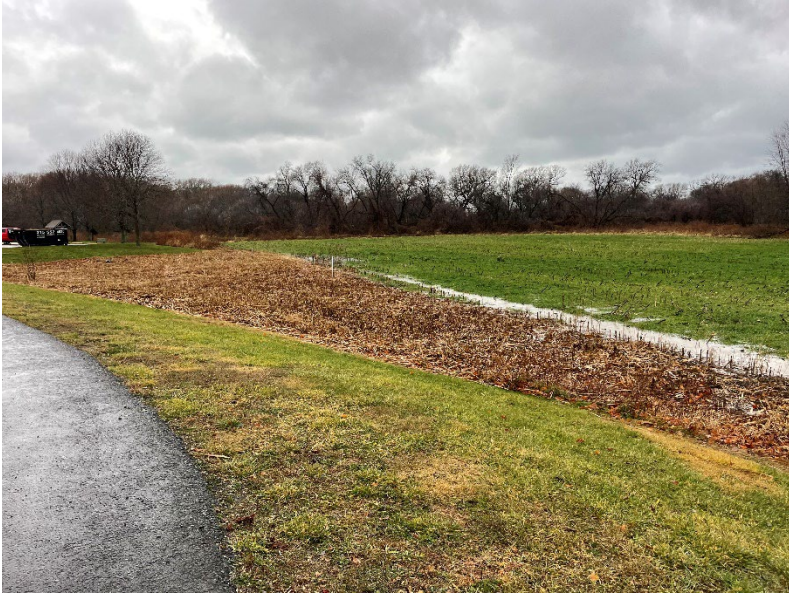
South Sandy Creek Phragmites patch post mowing

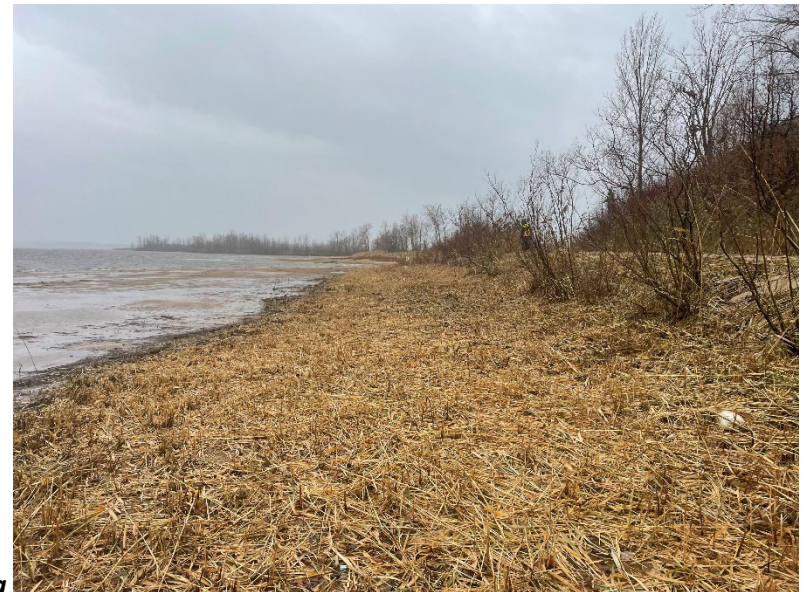
North Sandy Pond dense Phragmites patch post mowing
