**St. Lawrence River/Thousand Islands  
Emerald Ash Borer Early Detection Survey  
SLELO-PRISM Early Detection Surveillance**

June 3<sup>rd</sup> and 29<sup>th</sup> 2015

Report prepared by Elizabeth MacEwen and Caitlin Muller on July 1, 2015.

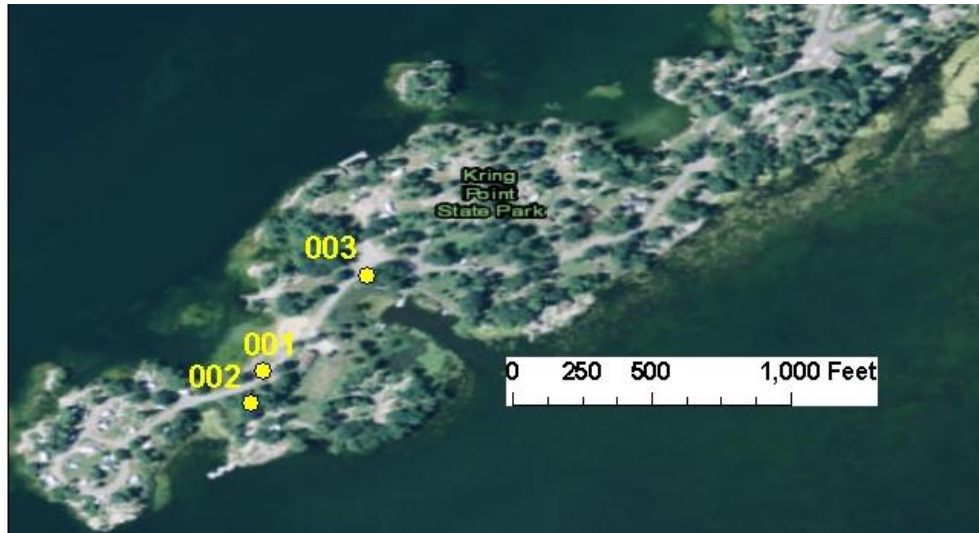
**Figure 4:** Map of Kring Point State Park, with ash stands recorded on June 3<sup>rd</sup>.

State Park	Waypoint	Latitude	Longitude	Notes
<u>Kring Point</u>	001	44.374785	-75.860651	Some possible die-back
	002	44.374468	-75.860763	Healthy stand
	003	44.375737	-75.859618	Healthy stand
<u>Keewaydin</u>	004	44.326164	-75.93175	Some canopy die-back
	005	44.324085	-75.933122	Little epicormic growth, some die-back

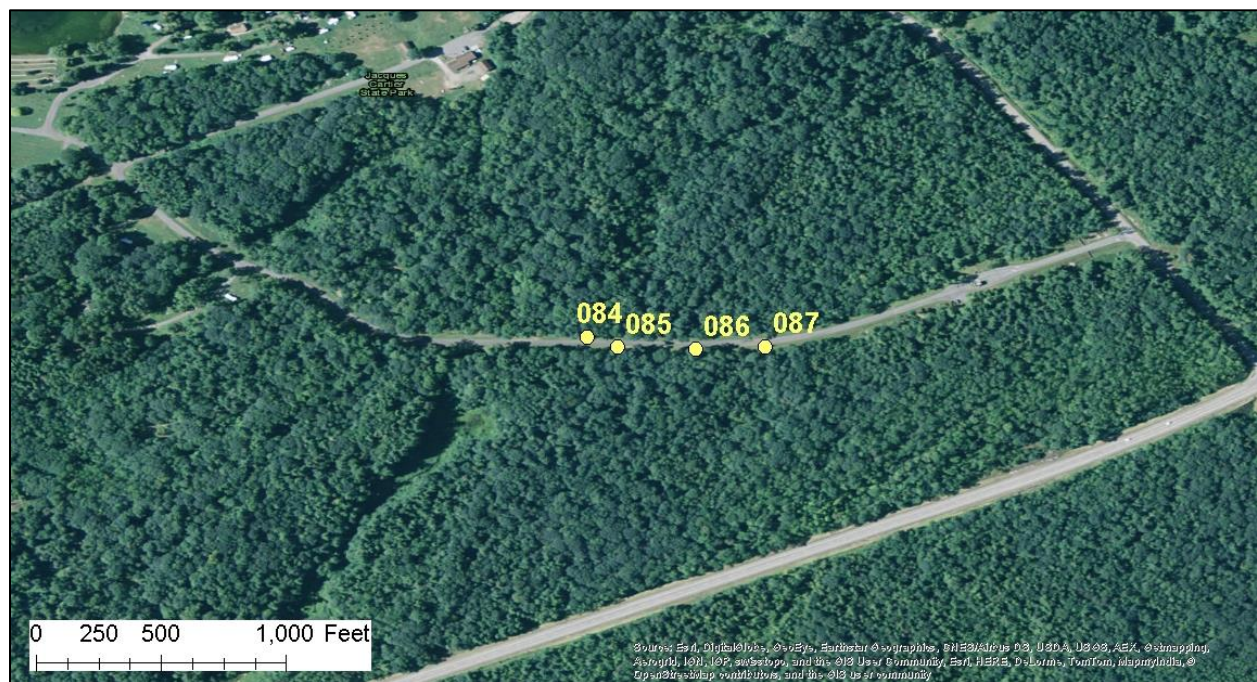
**Figure 9.** Map of Jacques Carter State Park

Park	Waypoint	Latitude	Longitude	Notes
Jaques Carter	84	44.55833	-75.683204	Small ash stand
	85	44.558216	-75.682872	Epicormic sprouts
	86	44.558192	-75.682009	Large epicormic sprouts and dieback
	87	44.558224	-75.681256	Two ash trees, one with a lot of dieback.
Kring Point	88	44.376693	-75.856637	Some blonding
	89	44.376597	-75.856848	Large exit holes, some smaller exit holes. One tree almost dead
	90	44.374758	-75.860675	Blonding on all trees, some sprouts
	91	44.375058	-75.860215	Blonding on all trees, some sprouts
	92	44.374495	-75.860828	Blonding on all trees, some sprouts
	93	44.375729	-75.859607	Large ash trees, slight blonding and some sprouts
	94	44.376015	-75.859099	Declining ash behind campsite
	95	44.377886	-75.855432	Two small dying ash trees, large holes in trees
	96	44.377894	-75.855446	duplicate point
Keewaydin	97	44.325384	-75.933338	Back of campground, blonding
	98	44.324084	-75.93312	Some epicormic sprouts and dieback.
